Section 5

Case studies

Case Study 1

State-wide eradication of seeding willows in Tasmania

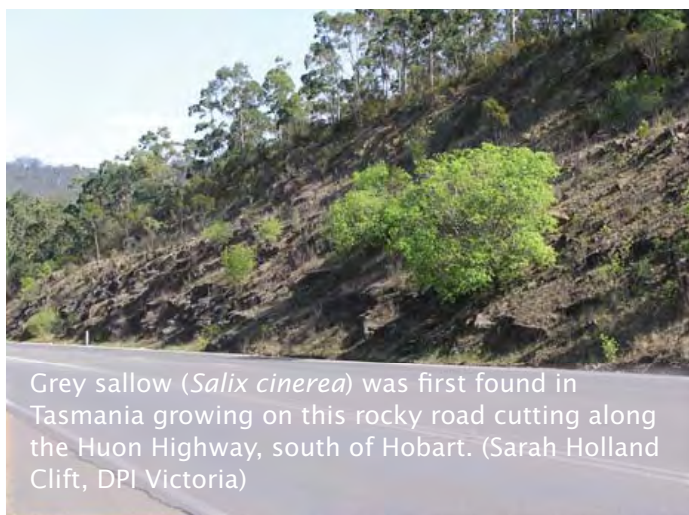
Grey willow (*Salix cinerea*) was first found in Tasmania growing on this rocky road cutting along the Huon Highway, south of Hobart. (Sarah Holland Clift, DPI Victoria)

Grey willow (*Salix cinerea*) was first noticed in Tasmania on a rocky road cutting on a main highway south of Hobart in 2000. Its discovery led to many other infestations being found in the surrounding area, where the seed had been carried by wind or water.

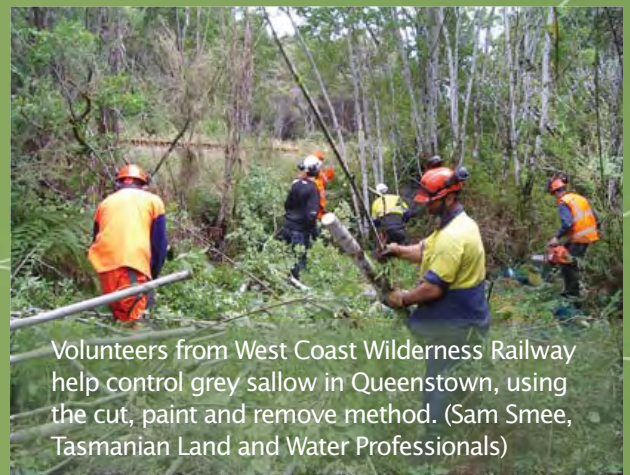
Volunteers from West Coast Wilderness Railway help control grey sallow in Queenstown, using the cut, paint and remove method. (Sam Smee, Tasmanian Land and Water Professionals)

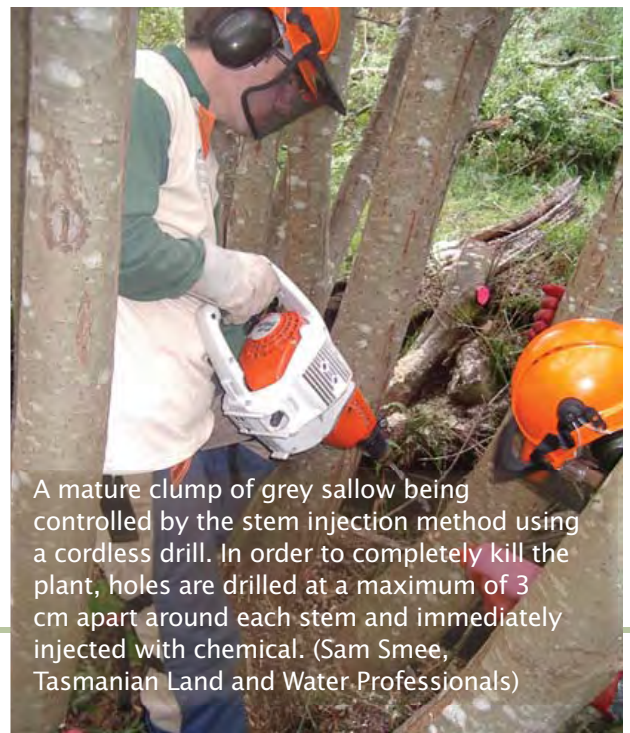
A mature clump of grey sallow being controlled by the stem injection method using a cordless drill. In order to completely kill the plant, holes are drilled at a maximum of 3 cm apart around each stem and immediately injected with chemical. (Sam Smee, Tasmanian Land and Water Professionals)

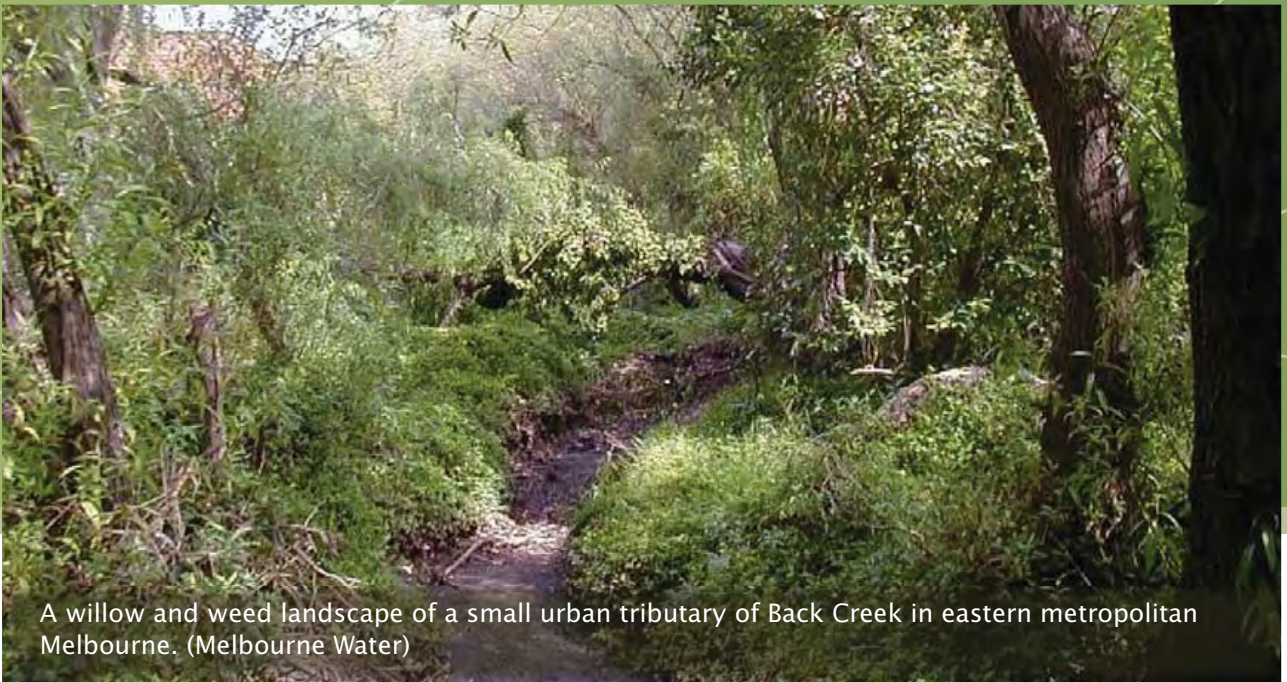
A willow and weed landscape of a small urban tributary of Back Creek in eastern metropolitan Melbourne. (Melbourne Water)

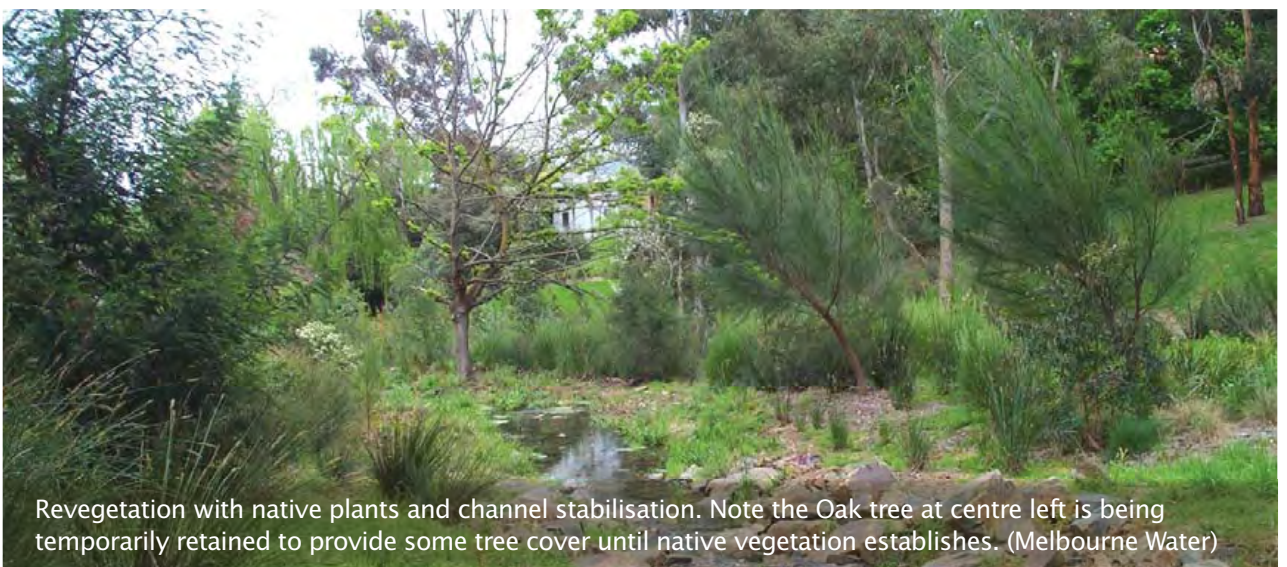
Revegetation with native plants and channel stabilisation. Note the Oak tree at centre left is being temporarily retained to provide some tree cover until native vegetation establishes. (Melbourne Water)

Because of a lack of remnant vegetation in the area, the site was actively revegetated after each stage of works. A dense ground layer of native species was established to out-compete weeds that otherwise continually reinfest such urban areas. Shrub and tree species were planted more sparsely to give a more open view of the river.

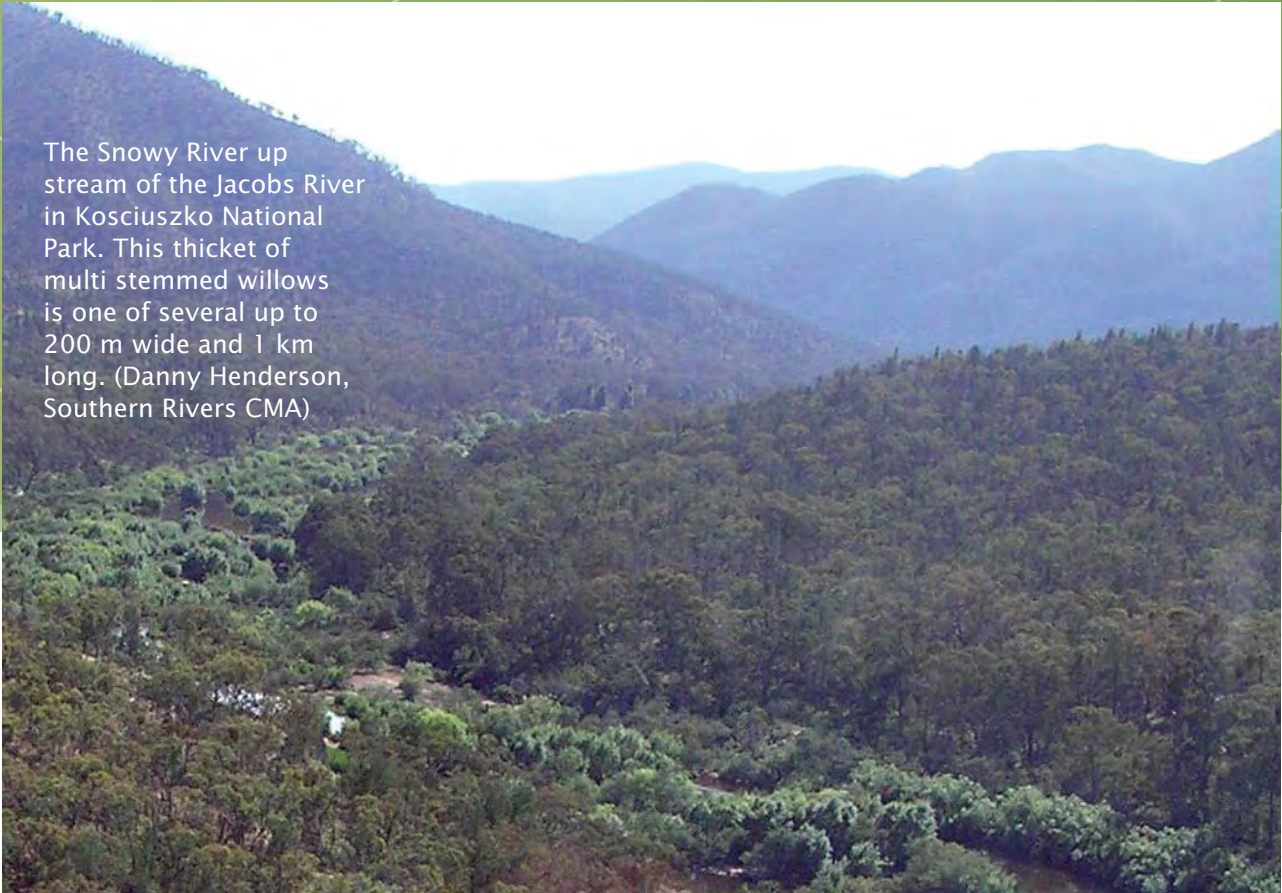
The Snowy River up stream of the Jacobs River in Kosciuszko National Park. This thicket of multi stemmed willows is one of several up to 200 m wide and 1 km long. (Danny Henderson, Southern Rivers CMA)

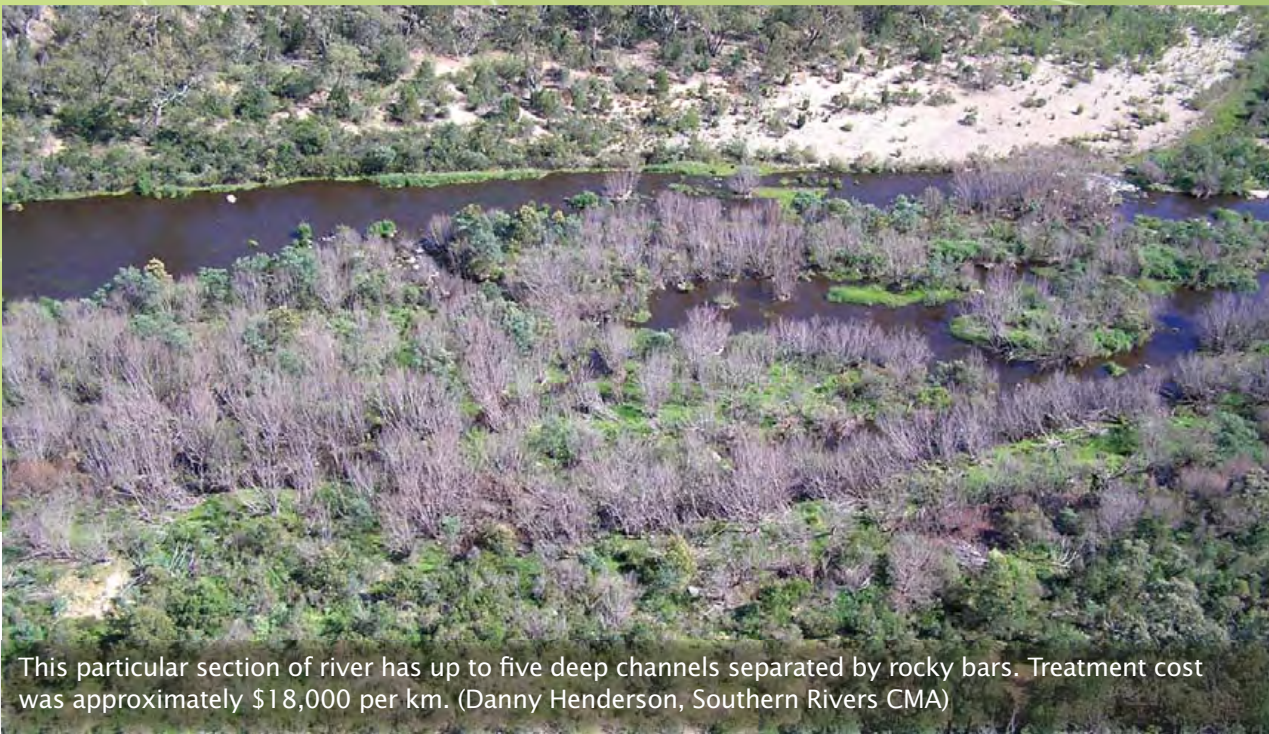
This particular section of river has up to five deep channels separated by rocky bars. Treatment cost was approximately \$18,000 per km. (Danny Henderson, Southern Rivers CMA)

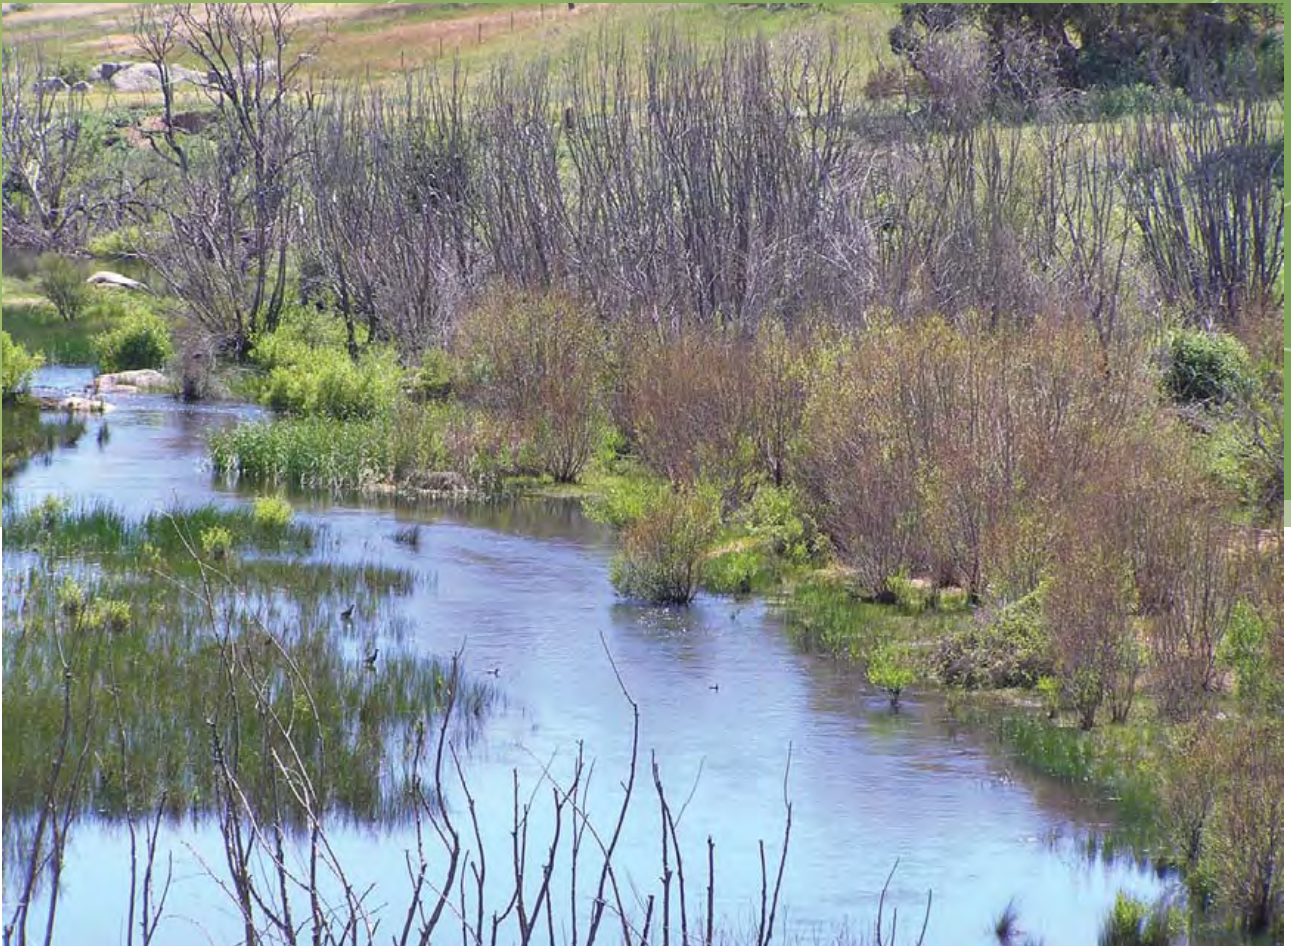
Follow-up foliar spray work was not done soon enough at this site, making treatment of these multi-stemmed three year old willows a similar cost to the initial treatment. (Danny Henderson, Southern Rivers CMA)

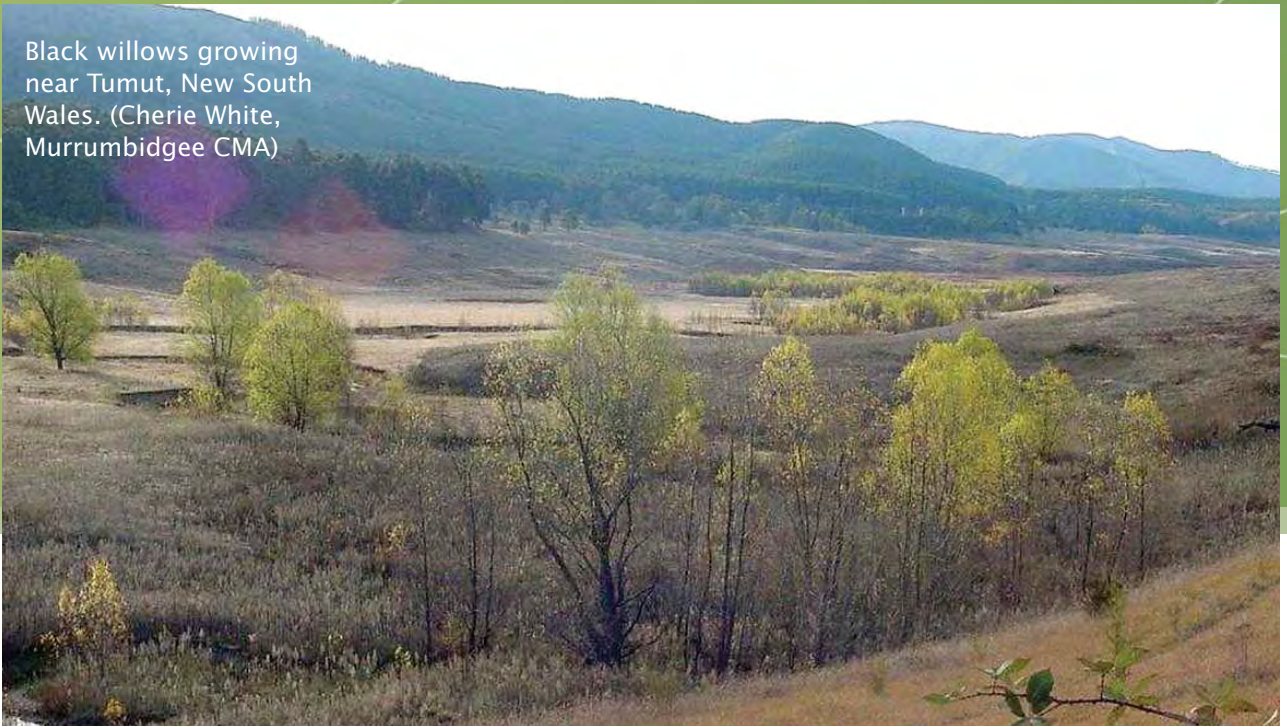
Black willows growing near Tumut, New South Wales. (Cherie White, Murrumbidgee CMA)

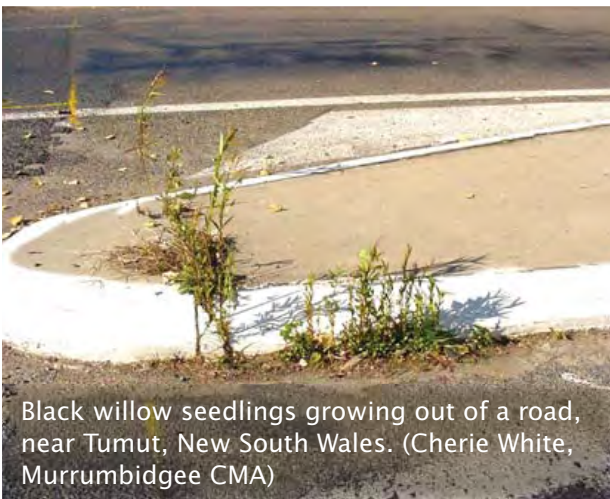
Black willow seedlings growing out of a road, near Tumut, New South Wales. (Cherie White, Murrumbidgee CMA)

Had the black willow seedlings not been detected and controlled so quickly, these seedlings could have grown much larger and become much more difficult and costly to control later on.

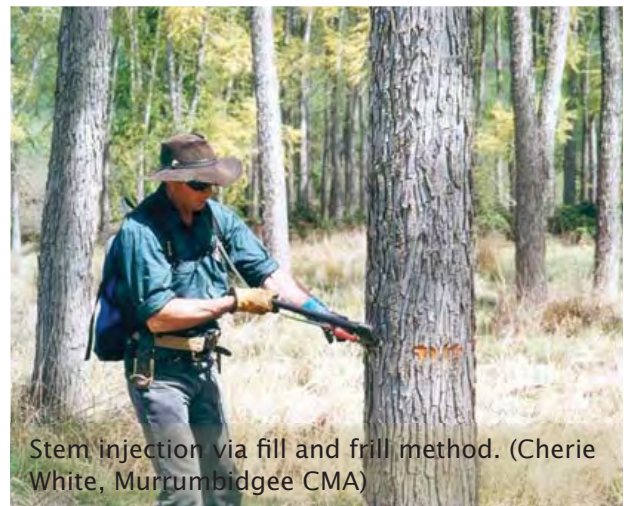
Stem injection via fill and frill method. (Cherie White, Murrumbidgee CMA)

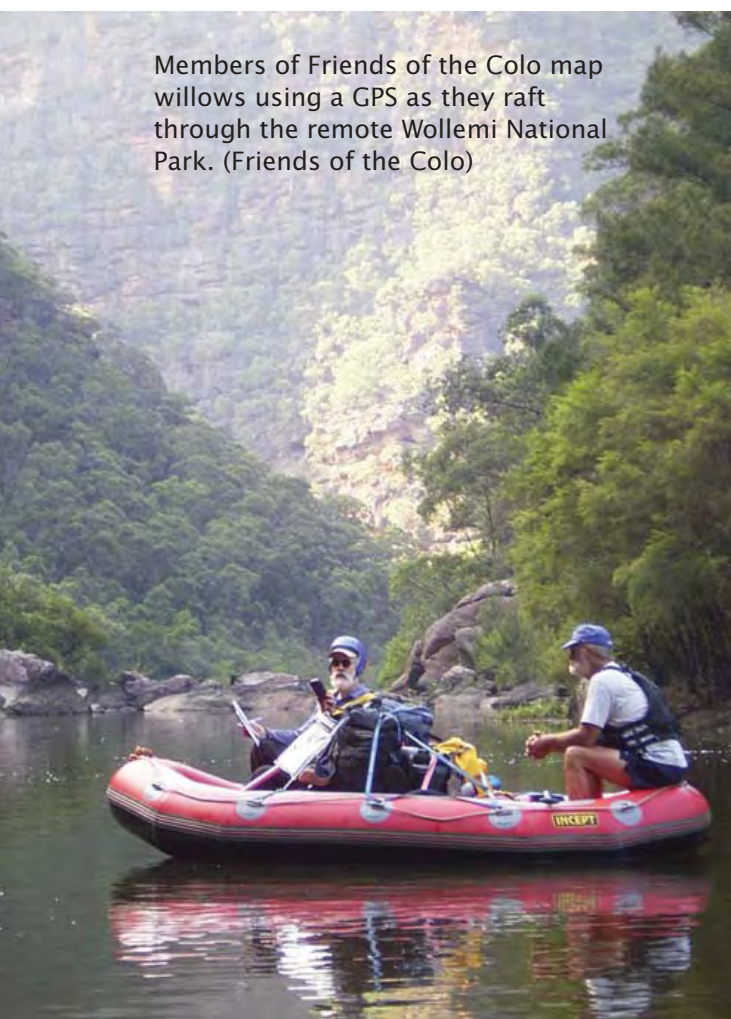
Members of Friends of the Colo map willows using a GPS as they raft through the remote Wollemi National Park. (Friends of the Colo)

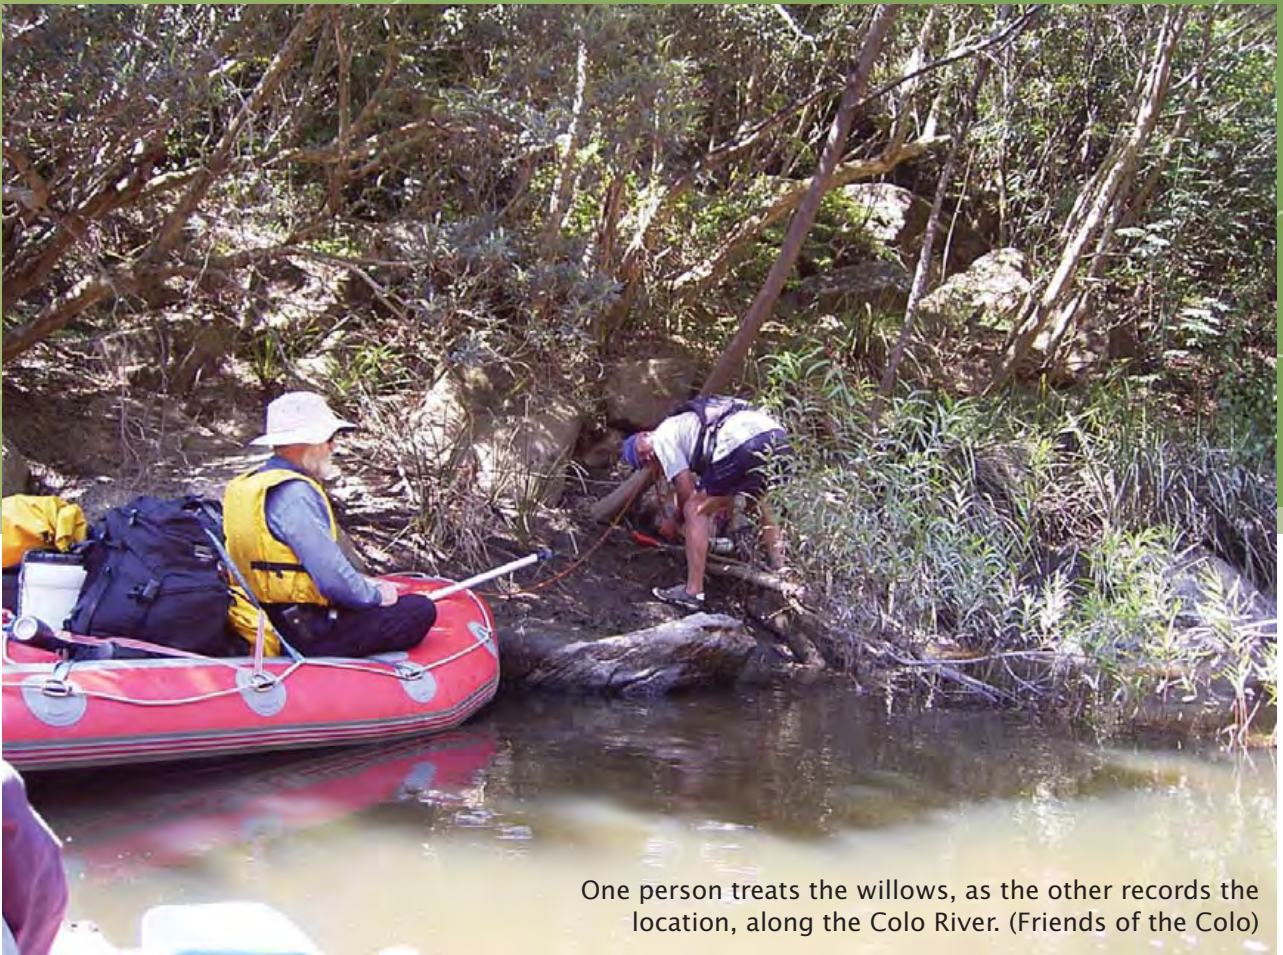
One person treats the willows, as the other records the location, along the Colo River. (Friends of the Colo)

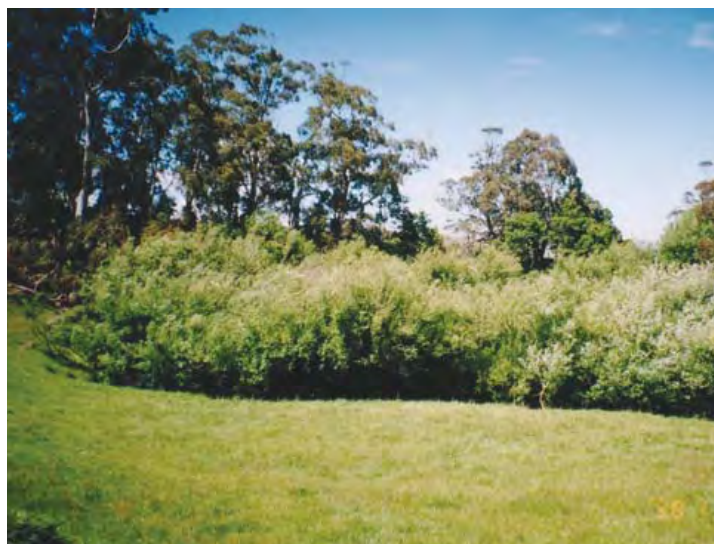
BEFORE: Willow infestation along the Bass River

A 20 tonne excavator and two qualified fellers worked together to remove dense willow stands at an average rate of 100 m per day. Trees were cut in situ, lifted from the river, stacked and then burnt. Stumps were poisoned using Roundup Biactive™.

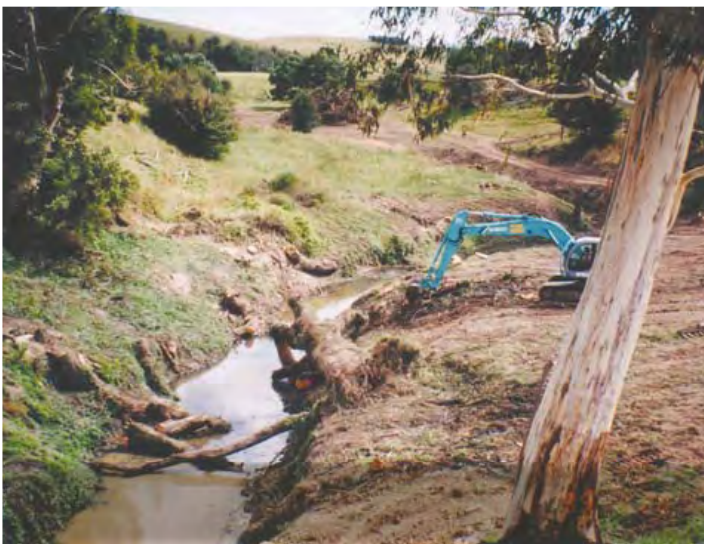
AFTER: willows removed from the Bass River

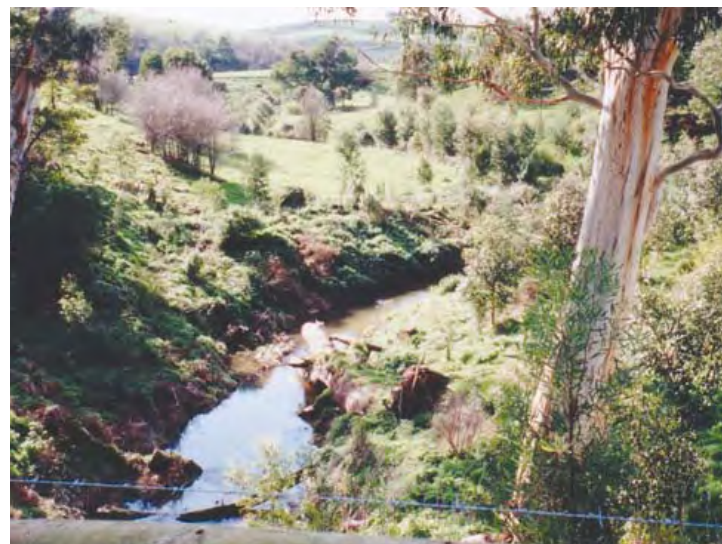
12 MONTHS LATER: fencing and revegetation completed, river health improved

- 97% of native tubes planted had survived
- very little willow regrowth had occurred, and
- water quality and macroinvertebrate diversity in the river had markedly improved.

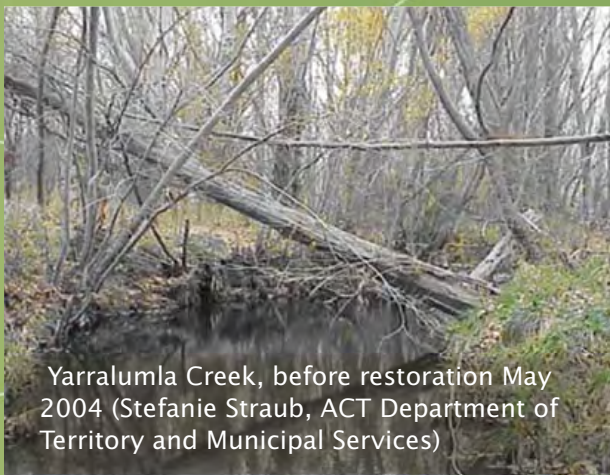
Yarralumla Creek, before restoration May 2004 (Stefanie Straub, ACT Department of Territory and Municipal Services)

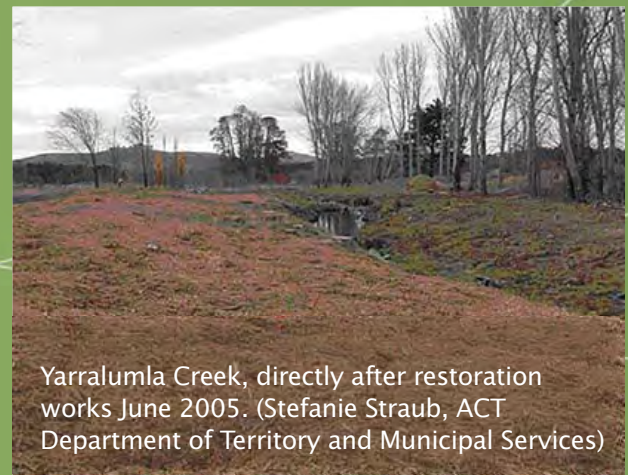
Yarralumla Creek, directly after restoration works June 2005. (Stefanie Straub, ACT Department of Territory and Municipal Services)
